**Limiting Future Flood Damage
To the
APS/APRL Headquarters**

**John H. Barwis, PhD
Consulting Geologist**

**Technical report prepared for the Executive Director,
The American Philatelic Society**

30 September 2008

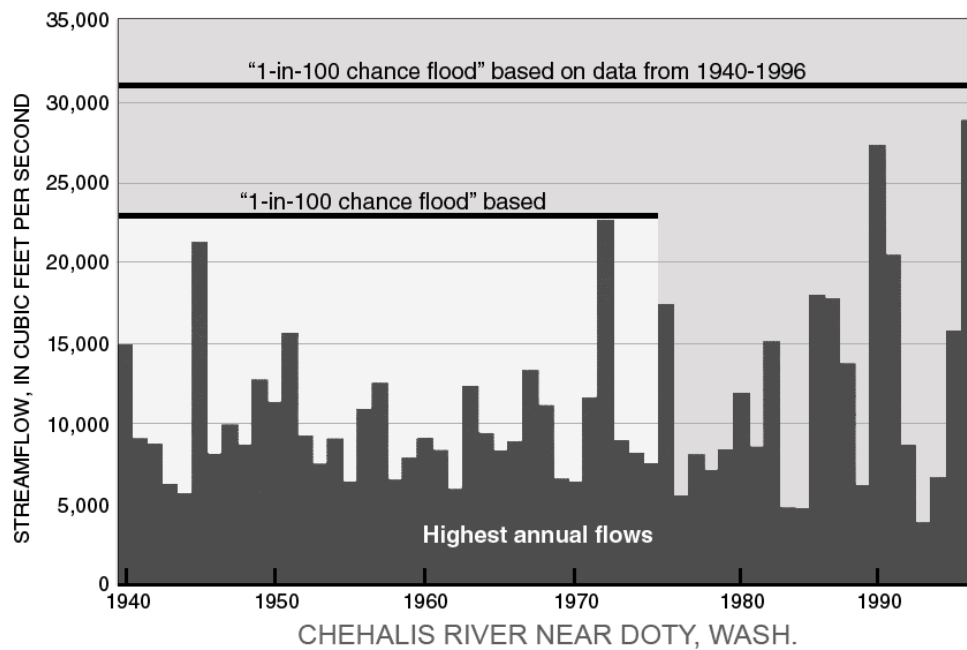
Figure 1. The effect of observation period on the definition of a 100-year flood. Data from the U.S. Geological Survey.²

The sparse data used to define the 100-year flood elevation for Bellefonte are in itself a risk, because uncertainties are poorly constrained. Hydrogeological studies have shown that longer observation periods and more extensive data-collection efforts usually result in **higher** values of the 100-year flood elevation, because more observations increase the likelihood of observing a rare event. A typical example of this concept is shown in **Figure 1**, which graphs discharge rates over 56 years for a river in Washington. Note that the definition of a 100-year flood is strongly dependent on the time period chosen for analysis. The apparent 35% increase in the predicted 100-year flood discharge – and the associated high-water level – is due solely to lengthening the observation period. Such detailed data do not exist for Spring Creek and Logan Branch, so we are unable to quantify the uncertainty around the current 100-year flood elevation except to say that it is probably too low.

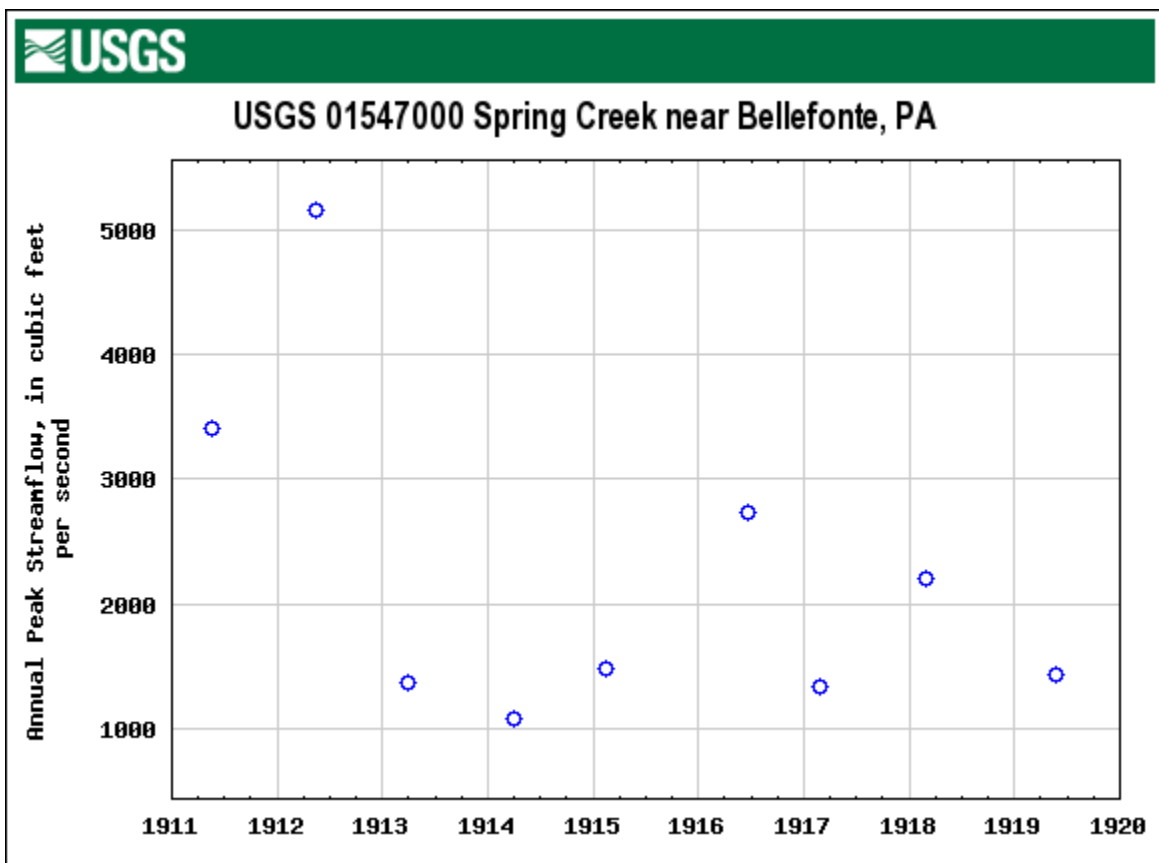
According to the USGS, the peak discharge in 1912 was on May 15, 1912...with a stream flow of 5,160 cfs, which correlates to a stage of 6.40 feet. Not sure what happened in March. I believe only the PEAK FLOW of each year is available on line, but he can try contacting John Nantz at USGS (717-736-6916) who is their Public Information person. Perhaps he would have additional "high water" events for the year, but I would say that the May event was the largest for 1912 (that's why it's the peak flow of the year). By the way...this 1912 reading was well above any other discharge/stage for the decade (1911-1919), with the second highest 3410 CFS and a stage of 5.4 feet. All other peak flows were in the 1K to 2K range. See table below.

C It is incorrect to assume that examining anecdotal information about three floods that occurred within a 65-year period is indicative of long-term trends, or has any predictive value, since none of these floods were 100-year events. What should have been addressed – and quantified – is how building and damage-mitigation plans would relate to the 50-, 100- and 500-year flood elevations predicted by the flood insurance study. Furthermore, ***there was a flood in May 1912*** (min. elevation 6.4 feet). See Appendix 4 for supporting data.
